# Intel® 41210 Serial to Parallel PCI Bridge

Specification Update

*September 2007*

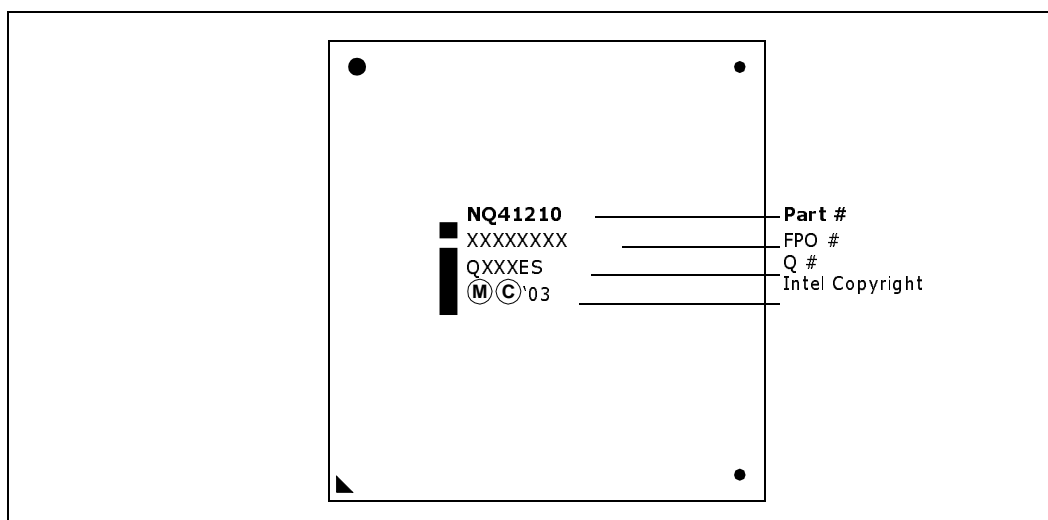
**Figure 1. Marking Information**

Stepping	Q Number	MM Number <sup>†</sup>	Notes
A1	Q645ES	857075	
B0	Q584ES	856480	
C0 with burn-in	Q718ES	858281	
C0 without burn-in	Q719ES	858282	
C1 with burn-in	Q812ES	861105	
C1 without burn-in	Q813ES	860905	
Production	SL7JE	860909
